## Diagnosing slab delaminations

Is improper finishing the only cause?

BY BRUCE A. SUPRENANT AND WARD R. MALISCH

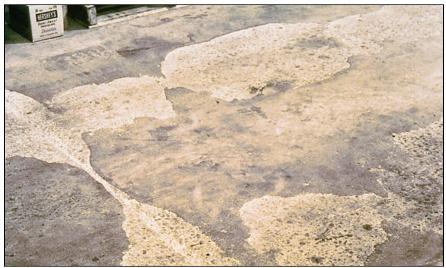
When delaminations form in floors, thin layers of the surface break away from the base concrete. Several factors contribute to the problem.

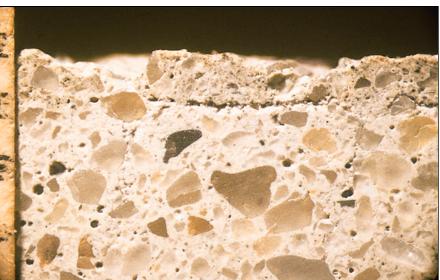
Figure 1. In this photomicrograph of an incipient delamination the connected elongated voids are 1 mm below and parallel to the finished surface. Each hatch mark on the left side of the slab is 1 mm.

the upper surface. Although the separations can be caused by rebar corrosion or freezing and thawing, on floors they're caused by a buildup of water and air beneath a dense layer of surface mortar (Fig. 1). Because the water and air create a weakened zone, traffic causes the surface layer to break away from the base concrete. Typically the delaminated surface mortar is ½ to ½ inch thick and the affected area from a few square inches to more than a hundred square feet (Refs. 1, 2).

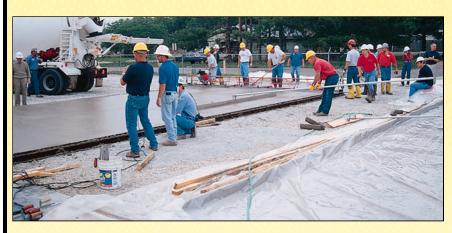
When floating passes were started four hours after strike-off, there was no bleedwater on the surface and the finishers' footprints were about ¼ inch deep. The power float passes went smoothly, but the first signs of trouble appeared during troweling. The surface started to peel (Fig. 1). A chain-drag survey 24 hours later revealed that 1.4% of the slab surface had delaminated (Fig. 2). Based on another survey at 28 days, the delaminated area had doubled. Delaminations occurred throughout the panel and didn't follow any tool or equipment pattern, thus ruling out float blades or pans as the cause.

Could it be the timing? The combined finisher experience totaled more than 100 years. All of the finishers and onsite observers represented more than 500 years of experience. No one believed the timing was inappropriate. The most likely cause of the delaminations was the entrained air. However, the air content at which entrained air became a problem wasn't clearly defined. Cores were taken from the panel and the 11.5% average air content of the hardened concrete was significantly higher than that of the fresh concrete. Based on fresh-concrete unit weight tests. the calculated air content was about 6.5%. Thus, the results of this test show that entrained air can cause surface delamination, but they don't define a threshold air content or shed any light on factors that affect that threshold.

Figure 2. After 24 hours, a chain-drag survey revealed that 1.4% of the slab surface was delaminated (spray-painted areas). A worker marks the delaminated area with spray paint. entrained concrete in slabs that require a machine-troweled surface.
